UNITED STATES ENVIRONMENTAL PROTECTION AGENCY

Re: Notice of Violation Compliance Evaluation Inspection EPA ID No. ILD 005 455 571

COMPLIANCE EVALUATION INSPECTION REPORT

INSTALLATION NAME: Rexnord Industries, LLC

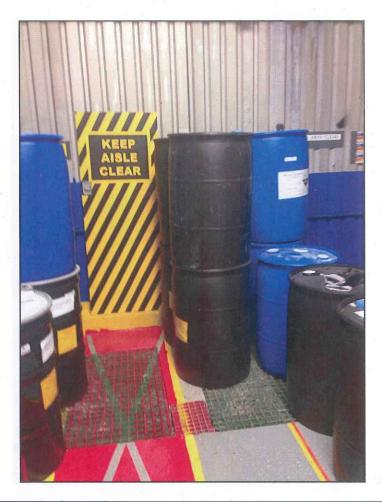
Photo 2	Rexnord	
	2400 Curtiss Street	
	Downers Grove, IL 60515	
4/22/15	Description: 90-day hazardous waste area. Immediately to the right	
11:53 am	of Photo 1. Four drums of hazardous waste, center of photo (to the	
Taken by: Michael Valentino	left of photo are the four hazardous waste drums seen in Photo 1).	
	Five plastic drums in the furthest row to the right are raw materials.

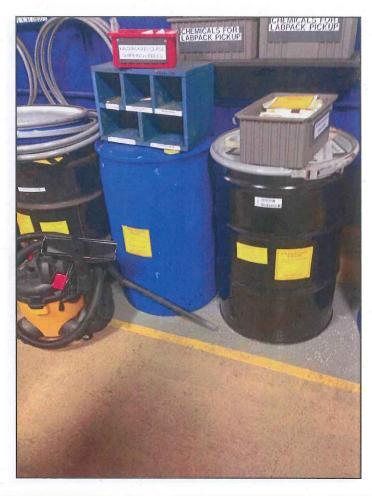
Photo 4	Rexnord
	2400 Curtiss Street
	Downers Grove, IL 60515
4/22/15	Description: Three satellite accumulation area drums. The drum to
11:56 am	the right appears in Photo 3.
Taken by: Michael Valentino
